Subject: Final Report - WO 89-6

SEATTLE CITY LIGHT WORK ORDER #89-6
1989 MONITORING OF THE GEORGETOWN FLUME

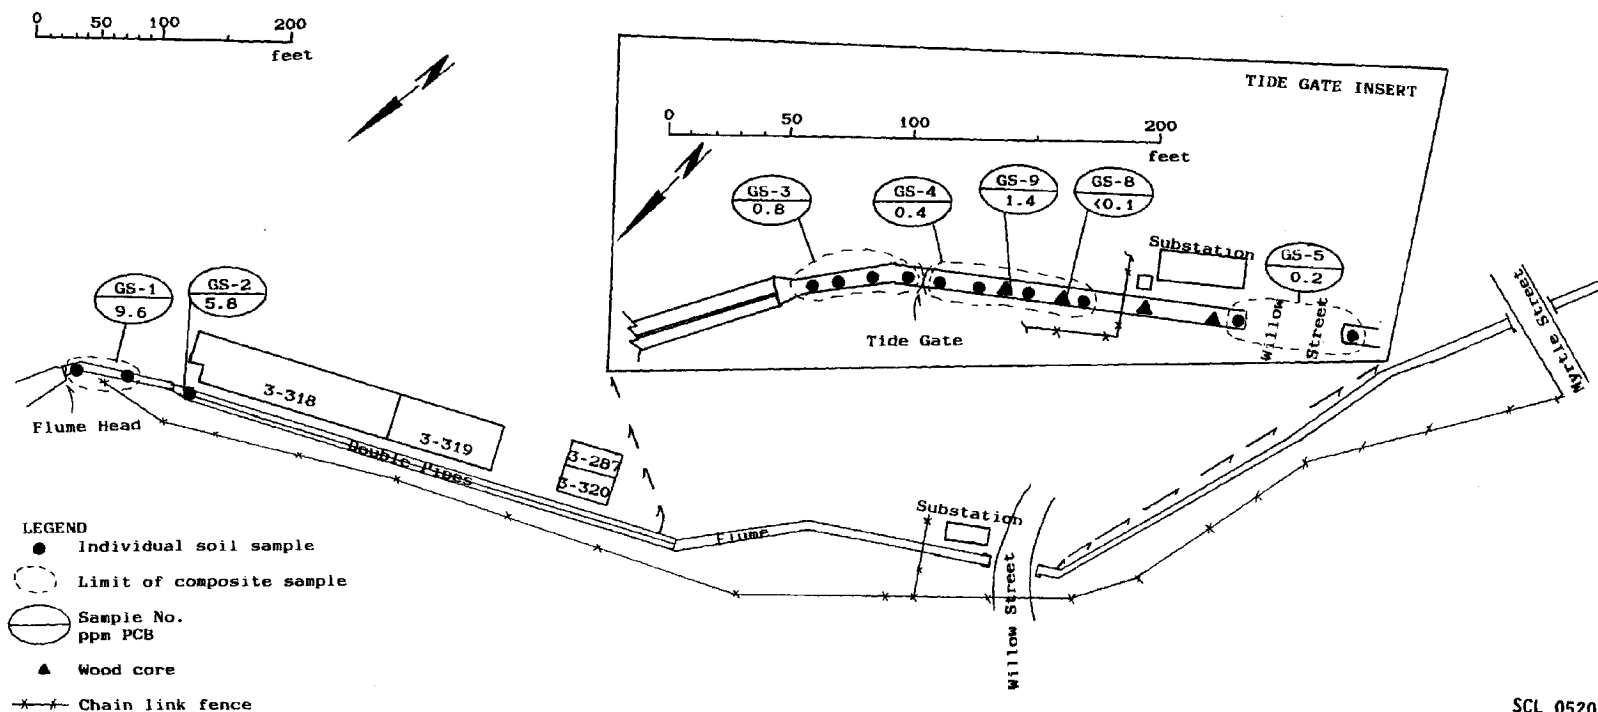
SCL GEORGETOWN FLUME SYSTEM
WINTER TESTING - 1989

Temperatures, as recorded with the $\pm 0.05^\circ$ C immersion thermometer, were air - 7.7° C, water in flume head - 7.4° C, water at double pipes head - 7.4° C. State of the tide was 7.0 ft. referenced to Seattle tides. The flume had been emptying of tidewater since noon. PCB results on Table I show that PCB residues remain in patches of the flume head system, where 9.6 ppm were found in the flume head sediment (composite of two) and 5.8 ppm were found at the head of the double pipes. Above the tidegates (composite of four subsamples), 0.8 ppm was detected. Below the tidegates the concentration was 0.4 ppm. The wood core samples below the tidegates were <0.1 and 1.4 ppm respectively.
